Home Inspection Report

13600 Marina Pointe Drive, Marina del Rey, CA 90292

Gary DeWitt
DeWitt Inspections

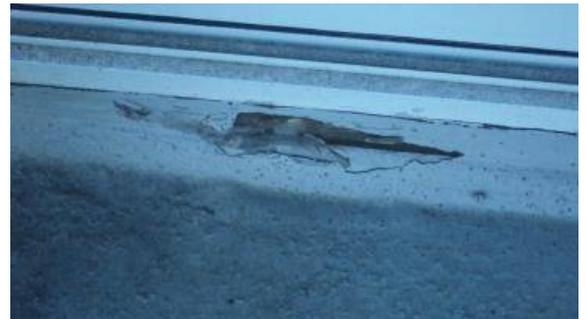
234 BALCONY

[CR] The balcony deck coating is cracked and damaged by the living room sliding door. This is conducive to moisture intrusion and further damage.

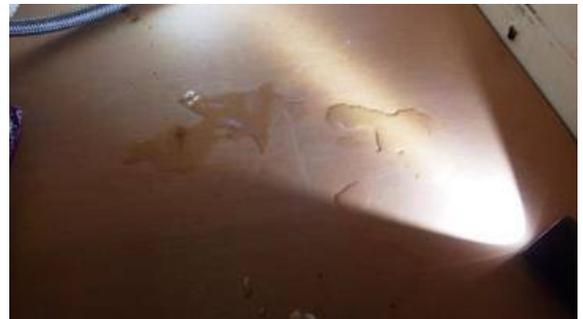
[CR] Active leaks were noted under the kitchen sink. I recommend locating and correcting the source and any damaged materials.

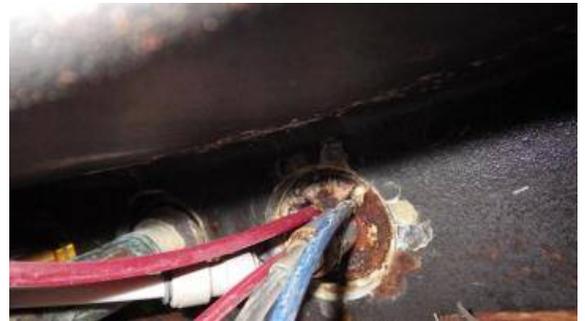
[CR] Moisture stains and faucet fixture corrosion noted on the underside of the kitchen counter at the sink. I recommend repair or replacement to prevent moisture intrusion and damage.

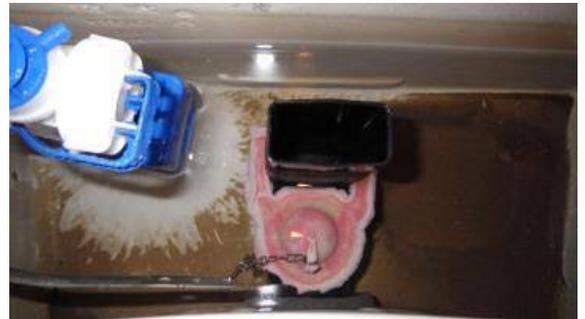
[CR] There were added on hoses at two of the toilets. The one in the second bedroom bath was leaking. These hoses are a potential source of cross contamination between waste and drinking water. They do not meet building standards. I recommend removing or replacing them with approved devices.

[SC] A cross-connection condition between potable and non-potable was water was noted at the added toilet hoses. I recommend correcting the condition noted.

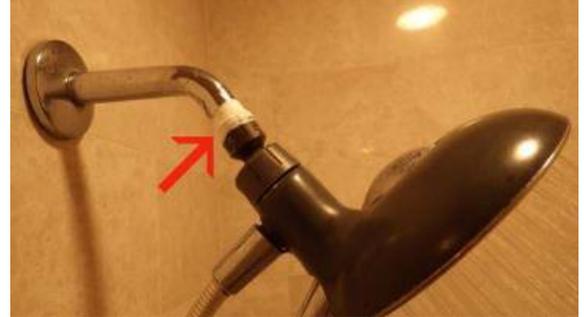
[CR] The shower arm to shower head joint at the master bathroom leaked. This is conducive to moisture intrusion into concealed spaces.

[FE] The shower subpan or receptor was not tested for watertightness.

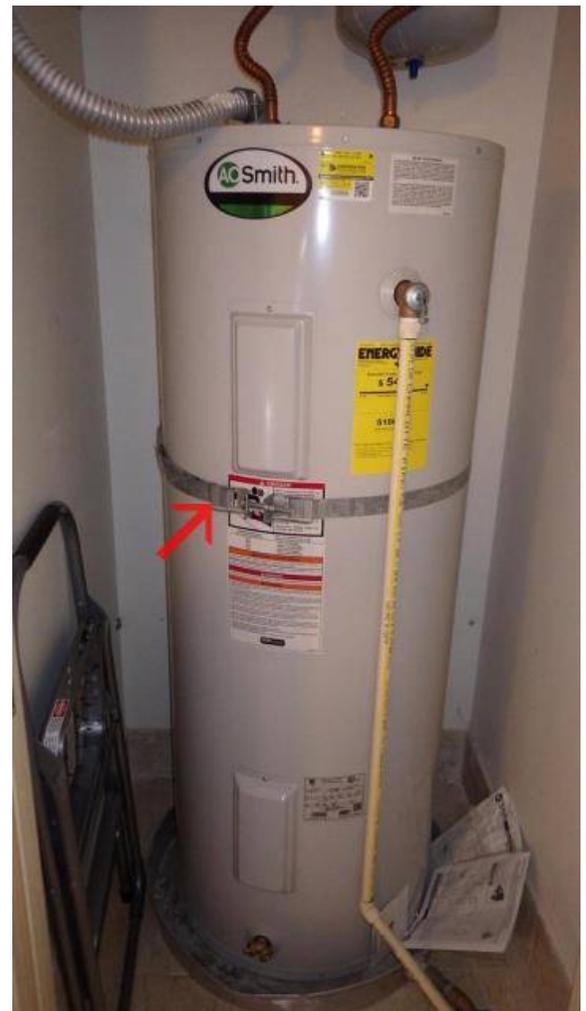
539 SEISMIC BRACING

[SC] The water heater seismic strapping was installed improperly, there was only one strap on an 80 gallon tank, 3 are required. I recommend obtaining a strapping kit and installing it, along with the required blocking, according to the manufacturers instructions and applicable to this size tank.

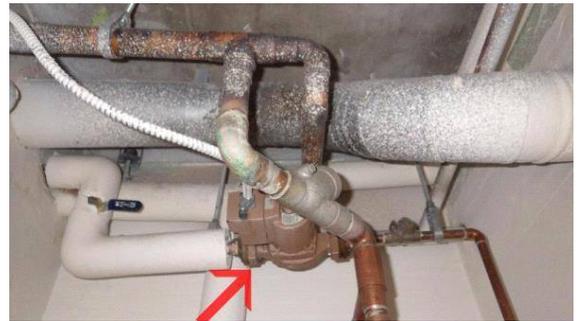
[RU] The recirculating system had a continuously running pump. Recirculating pumps or systems are not energy efficient, and can erode the pipes causing pin hole leaks. I recommend installing and using a time clock device to limit the use of the pump to the time(s) hot water need is anticipated.

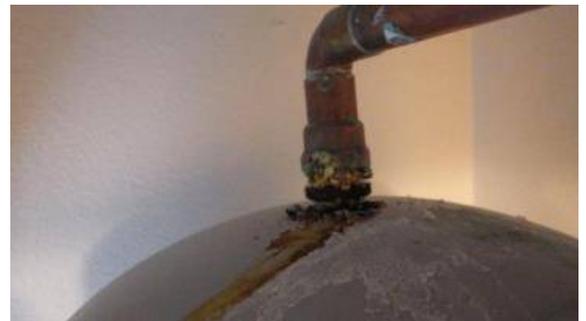
544 EXPANSION TANK

[CR] The expansion tank connection was corroded, indications of present or past leak on top of the tank. I recommend correcting this to prevent future leaks and potential damage.

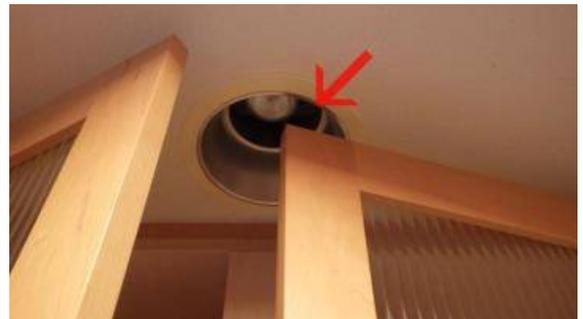
[SC] There was a halogen light over the kitchen sink. Halogen lamps are very hot. The cabinet door under the light, if left open, could become overheated by the light. This is a fire hazard.

[FE] Some of the lights failed to function at a number of rooms. I was unable to determine whether the bulbs or the fixtures failed. Some of the bulbs were missing altogether.

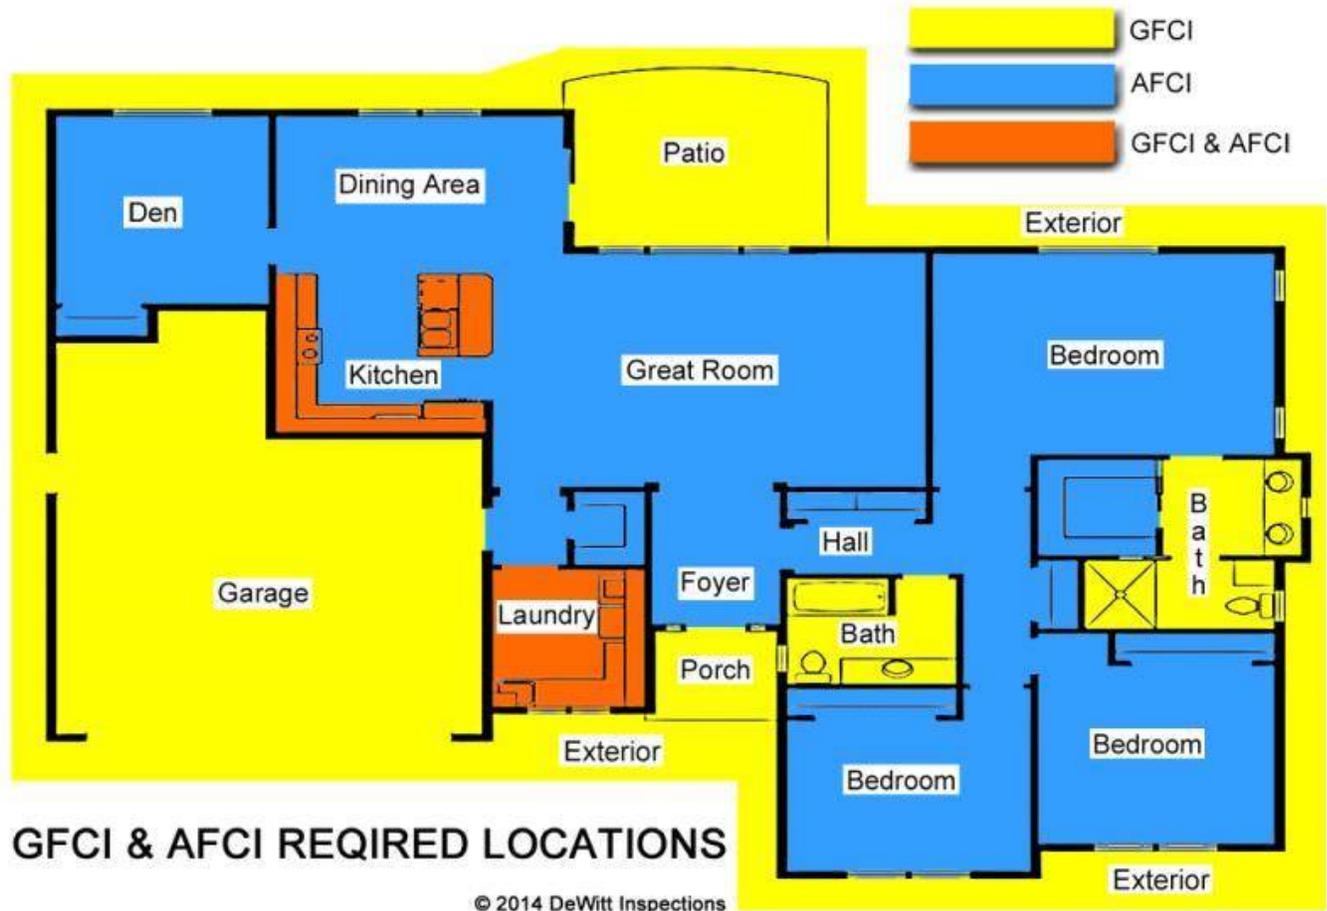
[RU] Ground fault circuit interrupters and arc fault circuit breakers were not present in all the locations and the panel as required today. I recommend adding them as a safety upgrade to help reduce shock and fire hazards.

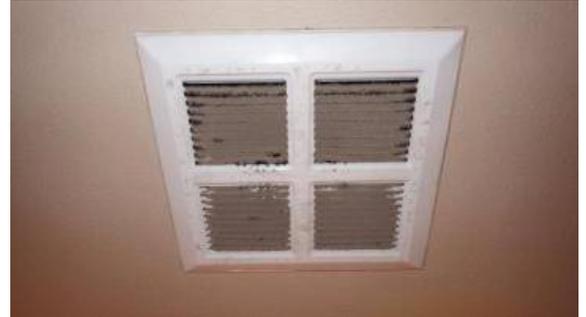
[CR] Bath fans were dirty, they should be cleaned for efficient operation, to help remove excess moisture and prevent microbial growth on surfaces.

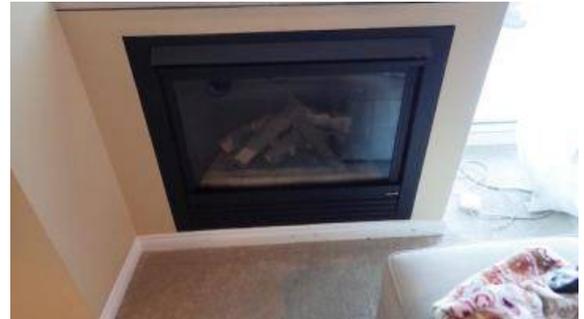
809 HEARTH EXTENSION

[SC] The hearth extension was not distinguishable from the surrounding flooring. This condition increases the potential for combustibile materials be placed too close to the fireplace. This condition is a fire safety hazard. I recommend correcting the condition or use caution in placement of items near fireplace.

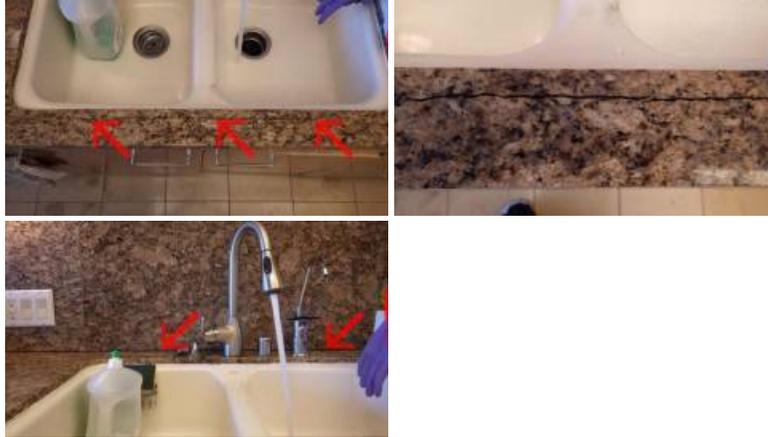
[CR] Surface or edge was cracked in front of the sink, the crack was separating. The counter was sagging and separating from the backsplash behind the sink.

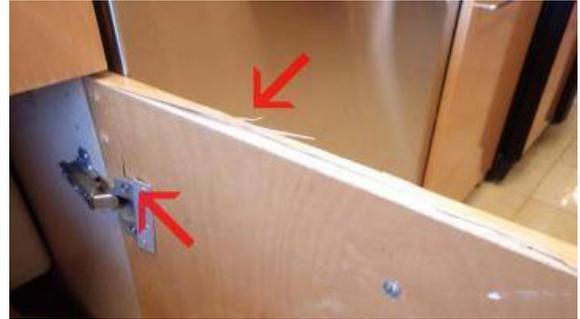
[CR] Sink cabinet doors were damaged.

[CR] The cabinet doors were uneven, rubbed and/or did not close properly by the oven.

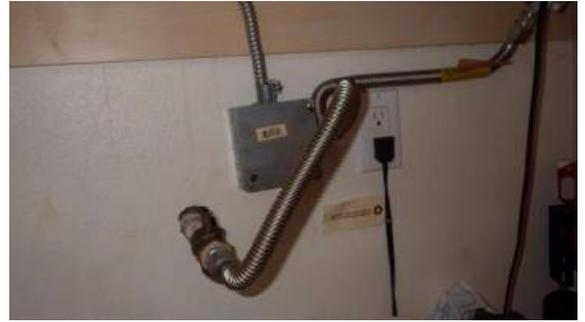
[SC] The flexible gas connector below the cook-top is not protected from pots and pans.

[RU] The gas shut-off valve required a wrench to be turned. I recommend upgrading to a hand operated valve for maintenance and emergencies. An angle valve would help keep the connector away from pots and pans.

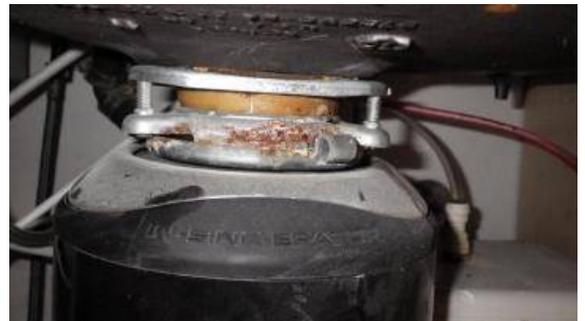
[FE] The disposer mounting ring was rusted. This indicates a present or past leak or seepage.

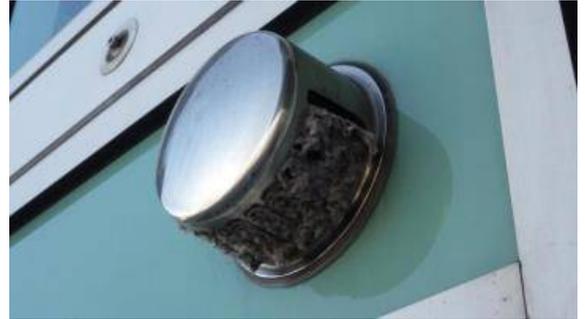
[SC] Dryer vent exterior termination was clogged with lint. This is a fire hazard and extends the drying time, wasting energy.

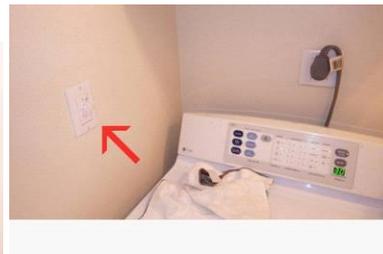
[NOTE] There was a dryer duct fan above an access panel in the hall ceiling to assist with dryer exhaust. The fan has a timer switch on the laundry room wall.

[SC] I recommend having the dryer connector, duct, assist fan and exterior termination cleaned by a duct cleaning company.

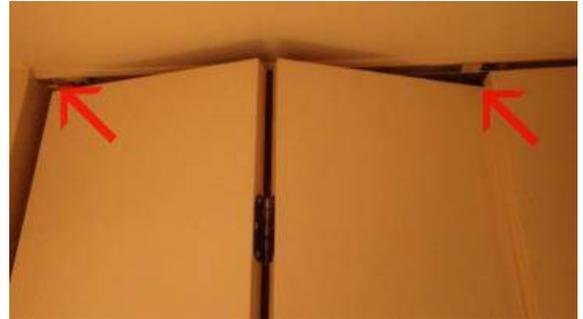
[CR] The doorknob at the master closet door was loose, damaged or was missing parts.

[CR] The hardware on the laundry area left door was missing a roller and out of adjustment, the doors would not close properly.

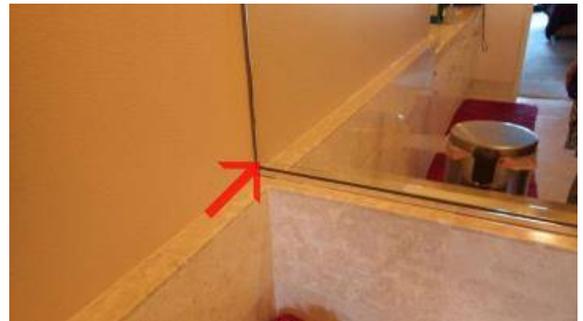
[SC] There were no visible safety glass markings on the mirror glass where subject to human impact at the master bath tub surround. I recommend the glass be confirmed as safety type or upgraded.
